Triax Accelerometer for Route-Based Vibration Analysis

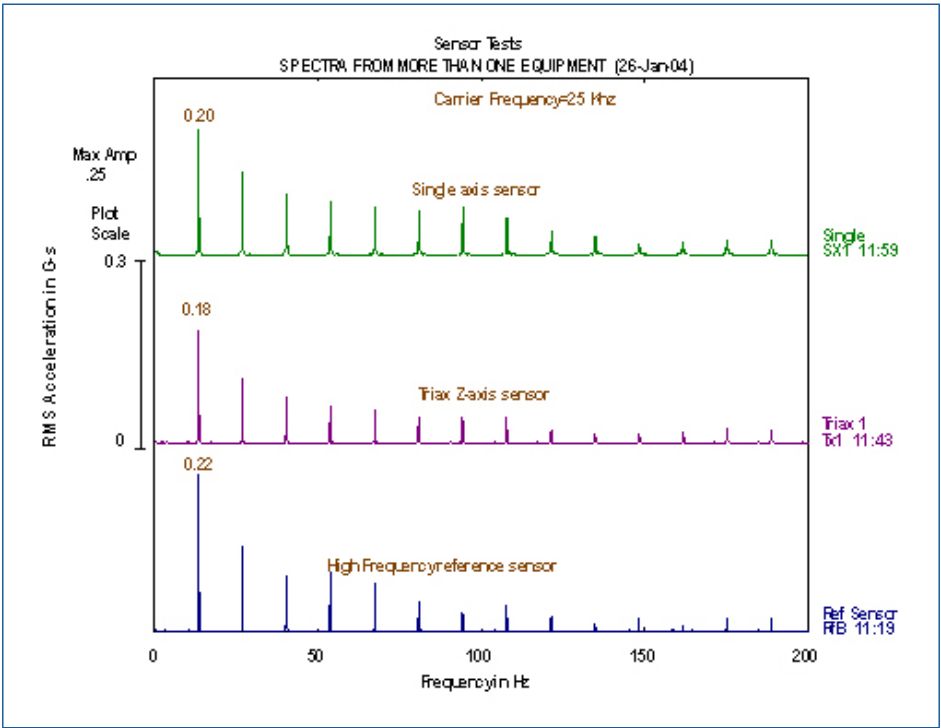
Figure 4. PeakVue response of high frequency accelerometer, z-axis of triax accelerometer and single axis accelerometer/flat rare earth magnet to an impulse excitation of 25 kHz carrier gated on 2 msec with a periodic rate of 13 per second.

The PeakVue™ spectral data acquired from the reference sensor, single axis sensor, and a triaxial (z direction) sensor for the case when the excitation frequency was 25 kHz are presented in Figure 4. The PeakVue spectral response of these three sensors with a second triaxial sensor at multiple carrier frequencies is tabulated in Table 1. The key observation is the z axis triaxial sensor is capable of detecting stress wave activity beyond the 25 kHz range which is sufficient to capture stress wave generated by impacting, fatiguing, and friction when mounted on a flat surface.

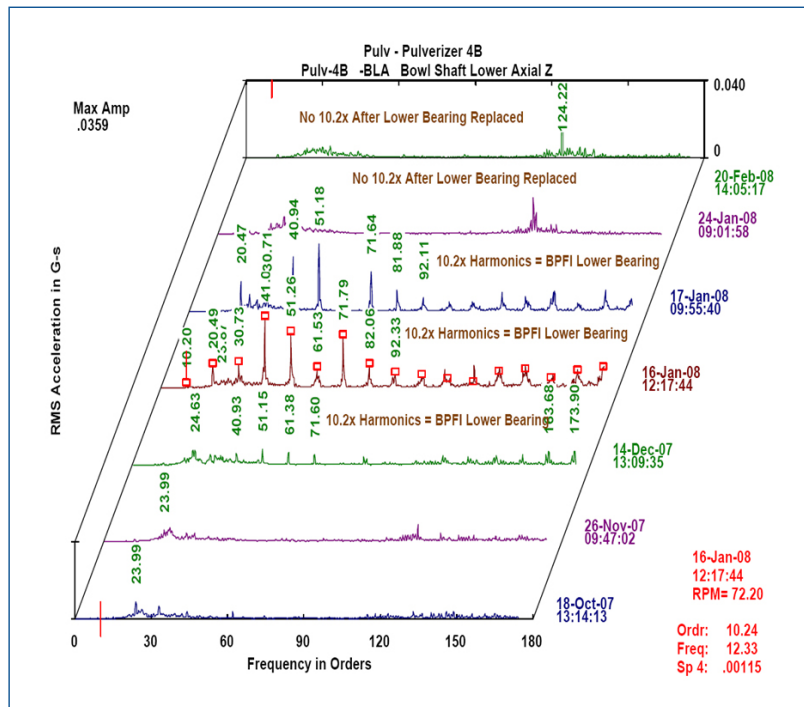
Figure 6. Water fall velocity spectral data from z-axis sensor on Pulverizer Gearbox over 6 month period with inner race fault present between December 14, 2007 and January 17, 2008 when bearing was replaced.

The velocity spectral data from the z sensor of the triax sensor placed on a curved surface on a Pulverizer gearbox are presented in Figure 5 clearly showing an inner race fault. The velocity spectral data acquired over a six month period from the same triax sensor mounted on the curved surface are presented in Figure 6. The defect was first observed in the December 14, 2007 data set and increased in severity level through the January 17, 2008 data set when the bearing was replaced. A photograph of the inner race from the removed bearing is presented in Figure 7 which shows significant damage.

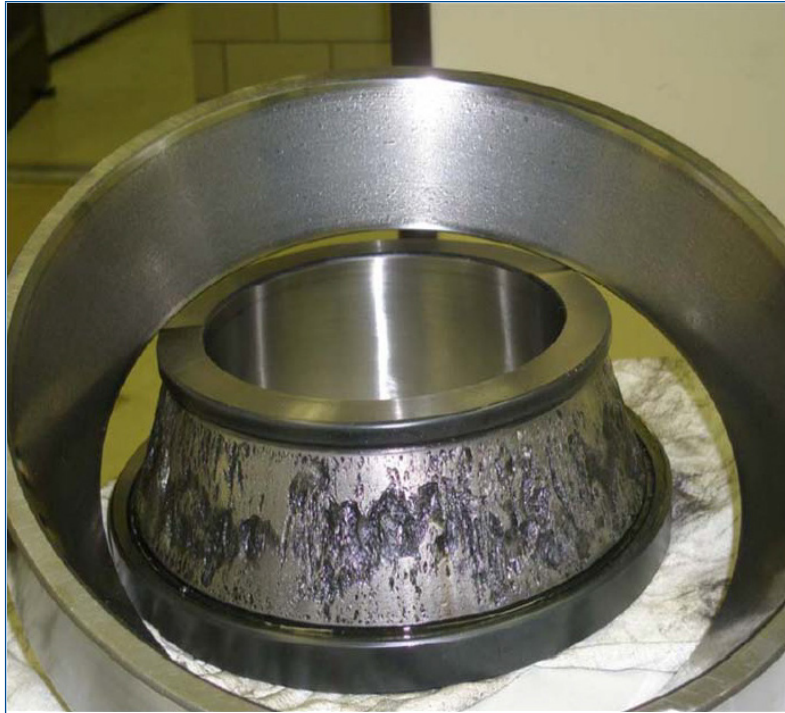
Figure 7. Photograph of the defective inner race from bearing removed from Pulverizer Gearbox following January 17, 2008 data set in Figure 6.

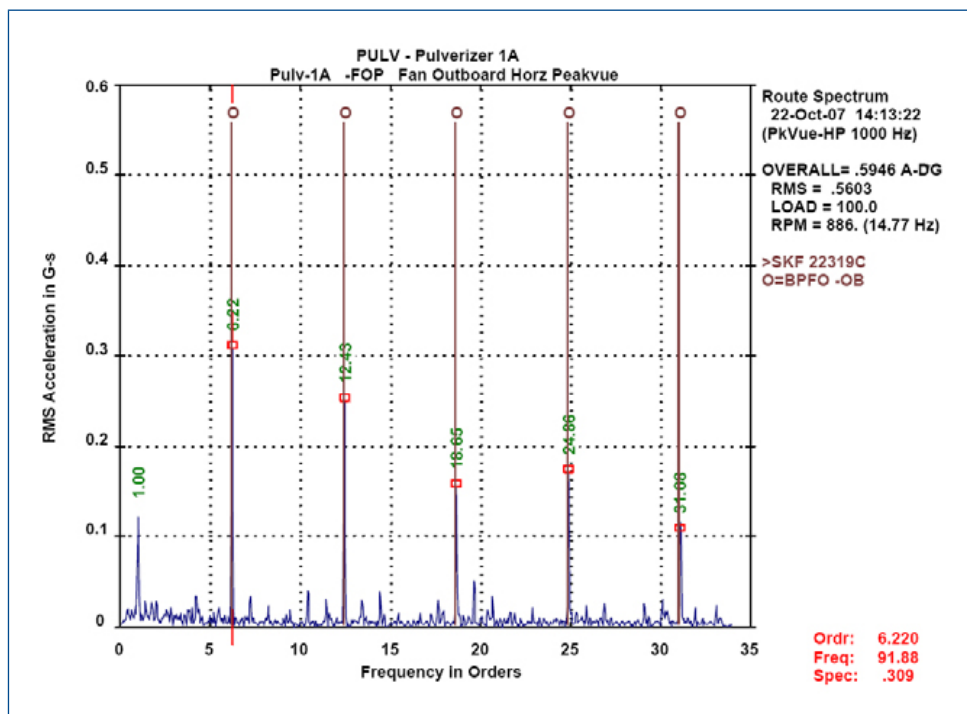
Figure 9. BPFO at same acquisition point of Figure 8 using Triax z-axis accelerometer on October 22, 2007. Note amplitude modulation has increased slightly relative to data in Figure 8.

An outer race defect detected on August 2, 2007 employing PeakVue from single axis accelerometer mounted on pulverizer exhaust fan is presented in Figure 8. On October 22, 2007, the triax sensor was being used for collection of route data. The PeakVue spectra from this same exhaust fan are presented in Figure 9. The outer race defect is still obvious, but with less amplitude at the defect frequency. The 1-x component has grown slightly and there are obvious side banding (amplitude modulation) of the BPFO fault activity with the running speed suggesting possible unbalance may be increasing.

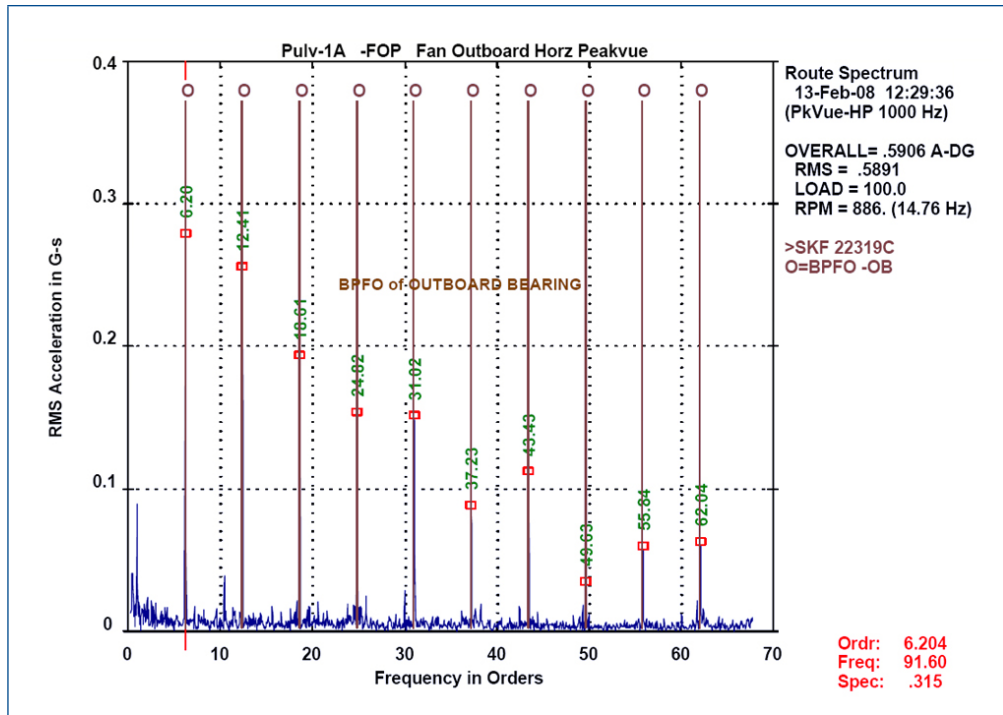
Figure 10. Z-axis PeakVue data from pulverizer exhaust fan on February 13, 2008 showing an outer race defect.

PeakVue spectra from the z sensor in triax accelerometer are presented in Figure 10 from pulverizer exhaust fan clearly showing BPFO fault. The peak g-level trend data from the PeakVue waveform are presented in Figure 11 over a 5+ month period. The bearing was replaced near March 4, 2008 showing significant decrease in the peak g-level amplitude. A photograph of the defective bearing (showing fluting) is presented in Figure 12.

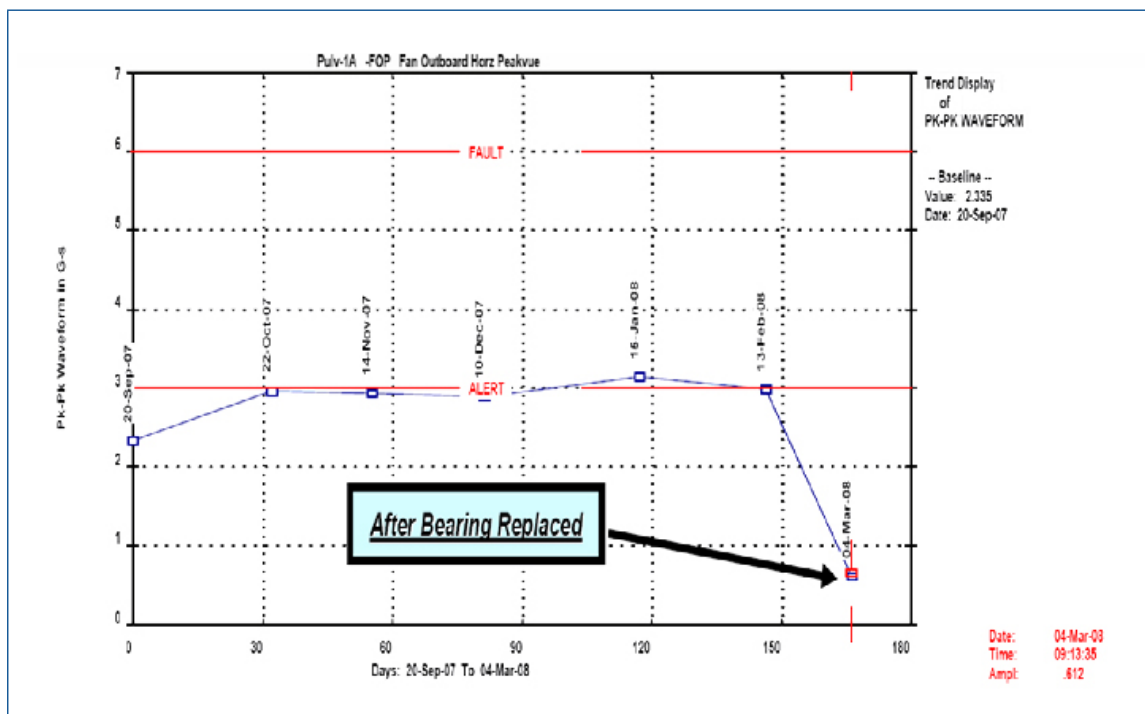
Figure 11. Peak g-level PeakVue trend data from z-axis sensor over 5.5 month period from same measurement point from which PeakVue spectra data in Figure 10 acquired.

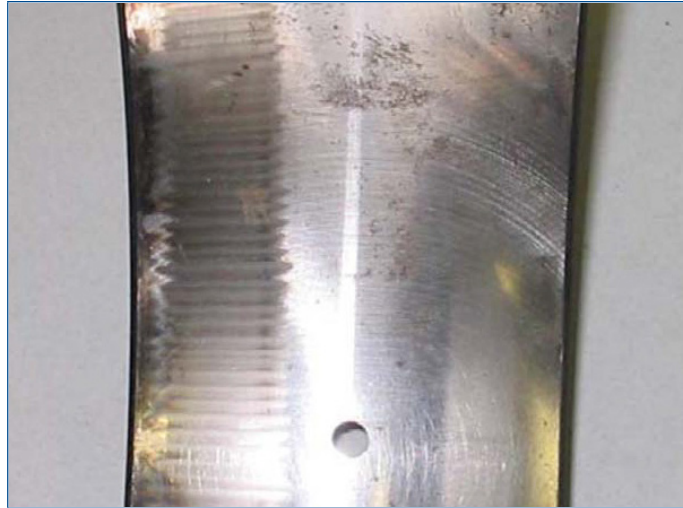
Figure 12. Defective bearing (fluting) from Pulverizer exhaust fan where data presented in Figures 10 and 11 were acquired.
